United States
Circuit Court of Appeals
For the Ninth Circuit.

UNITED STATES OF AMERICA,
Appellant,

J. LESLIE MORRIS COMPANY, INC., a cor-
poration,
Appellee.

Transcript of Record
(Plaintiff's Exhibits 1 to 32)

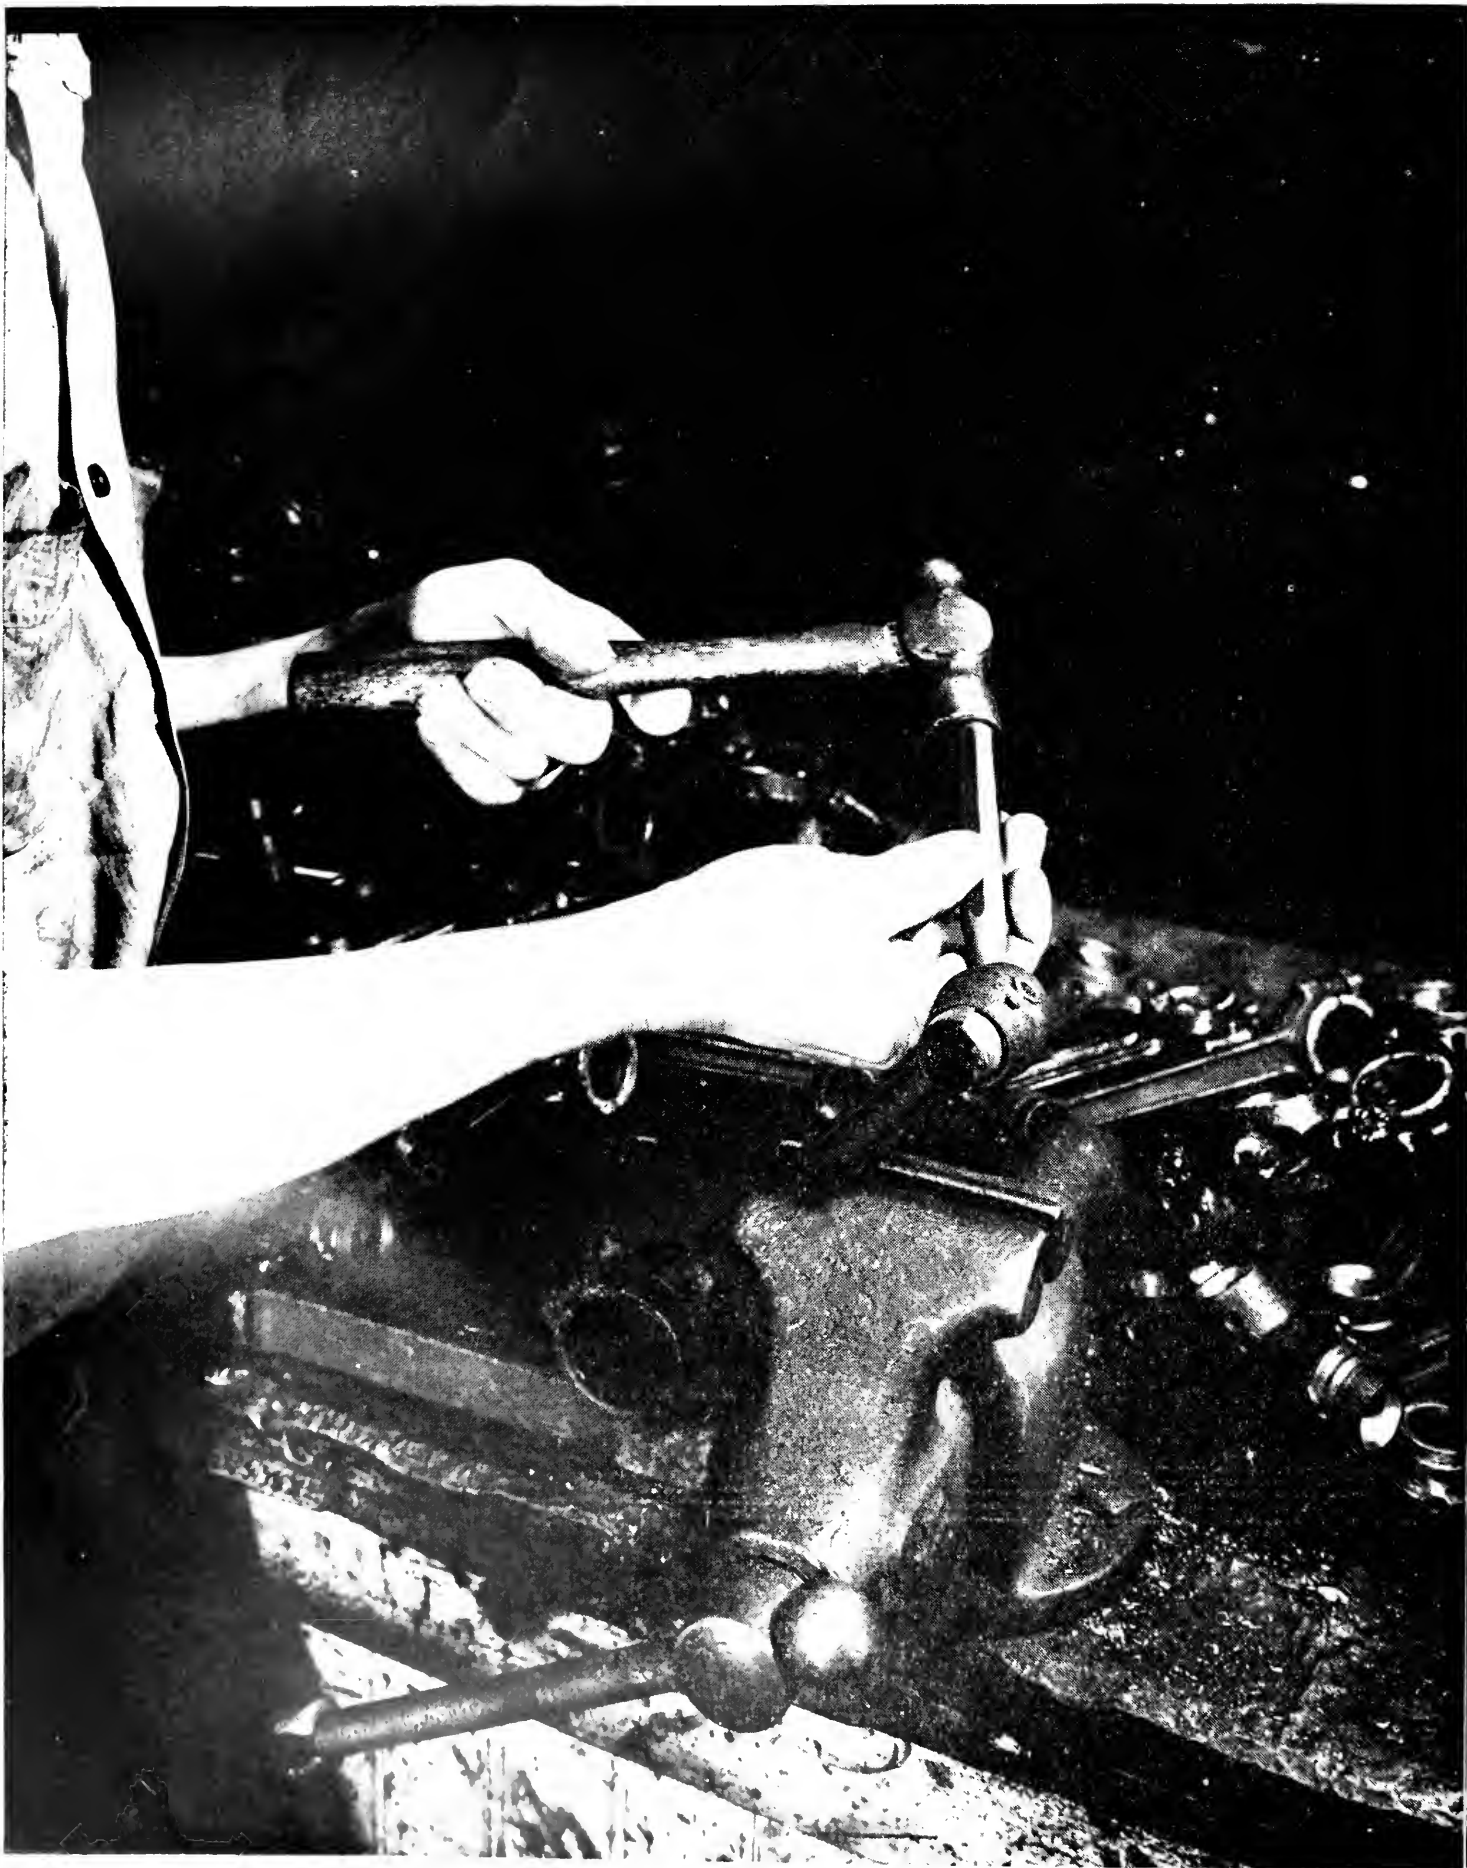
PLAINTIFF'S EXHIBIT No. 3

The rods are then piled on a table in groups according to their respective sizes and the pin bushings are removed. These pin bushings are the bushings at the shank end of the rod. About one half of the rods rebattitted by Plaintiff corporation use pin bushings. The other half are of a clamp type shank end and using no such pin bushings this operation of removal is not necessary. And sometimes the instructions received read "Do not change bushings." These pin bushings are of two types: Those with a thin wall which cannot be pressed out and which must be therefore pounded out by means of a cold chisel and hammer as shown above while

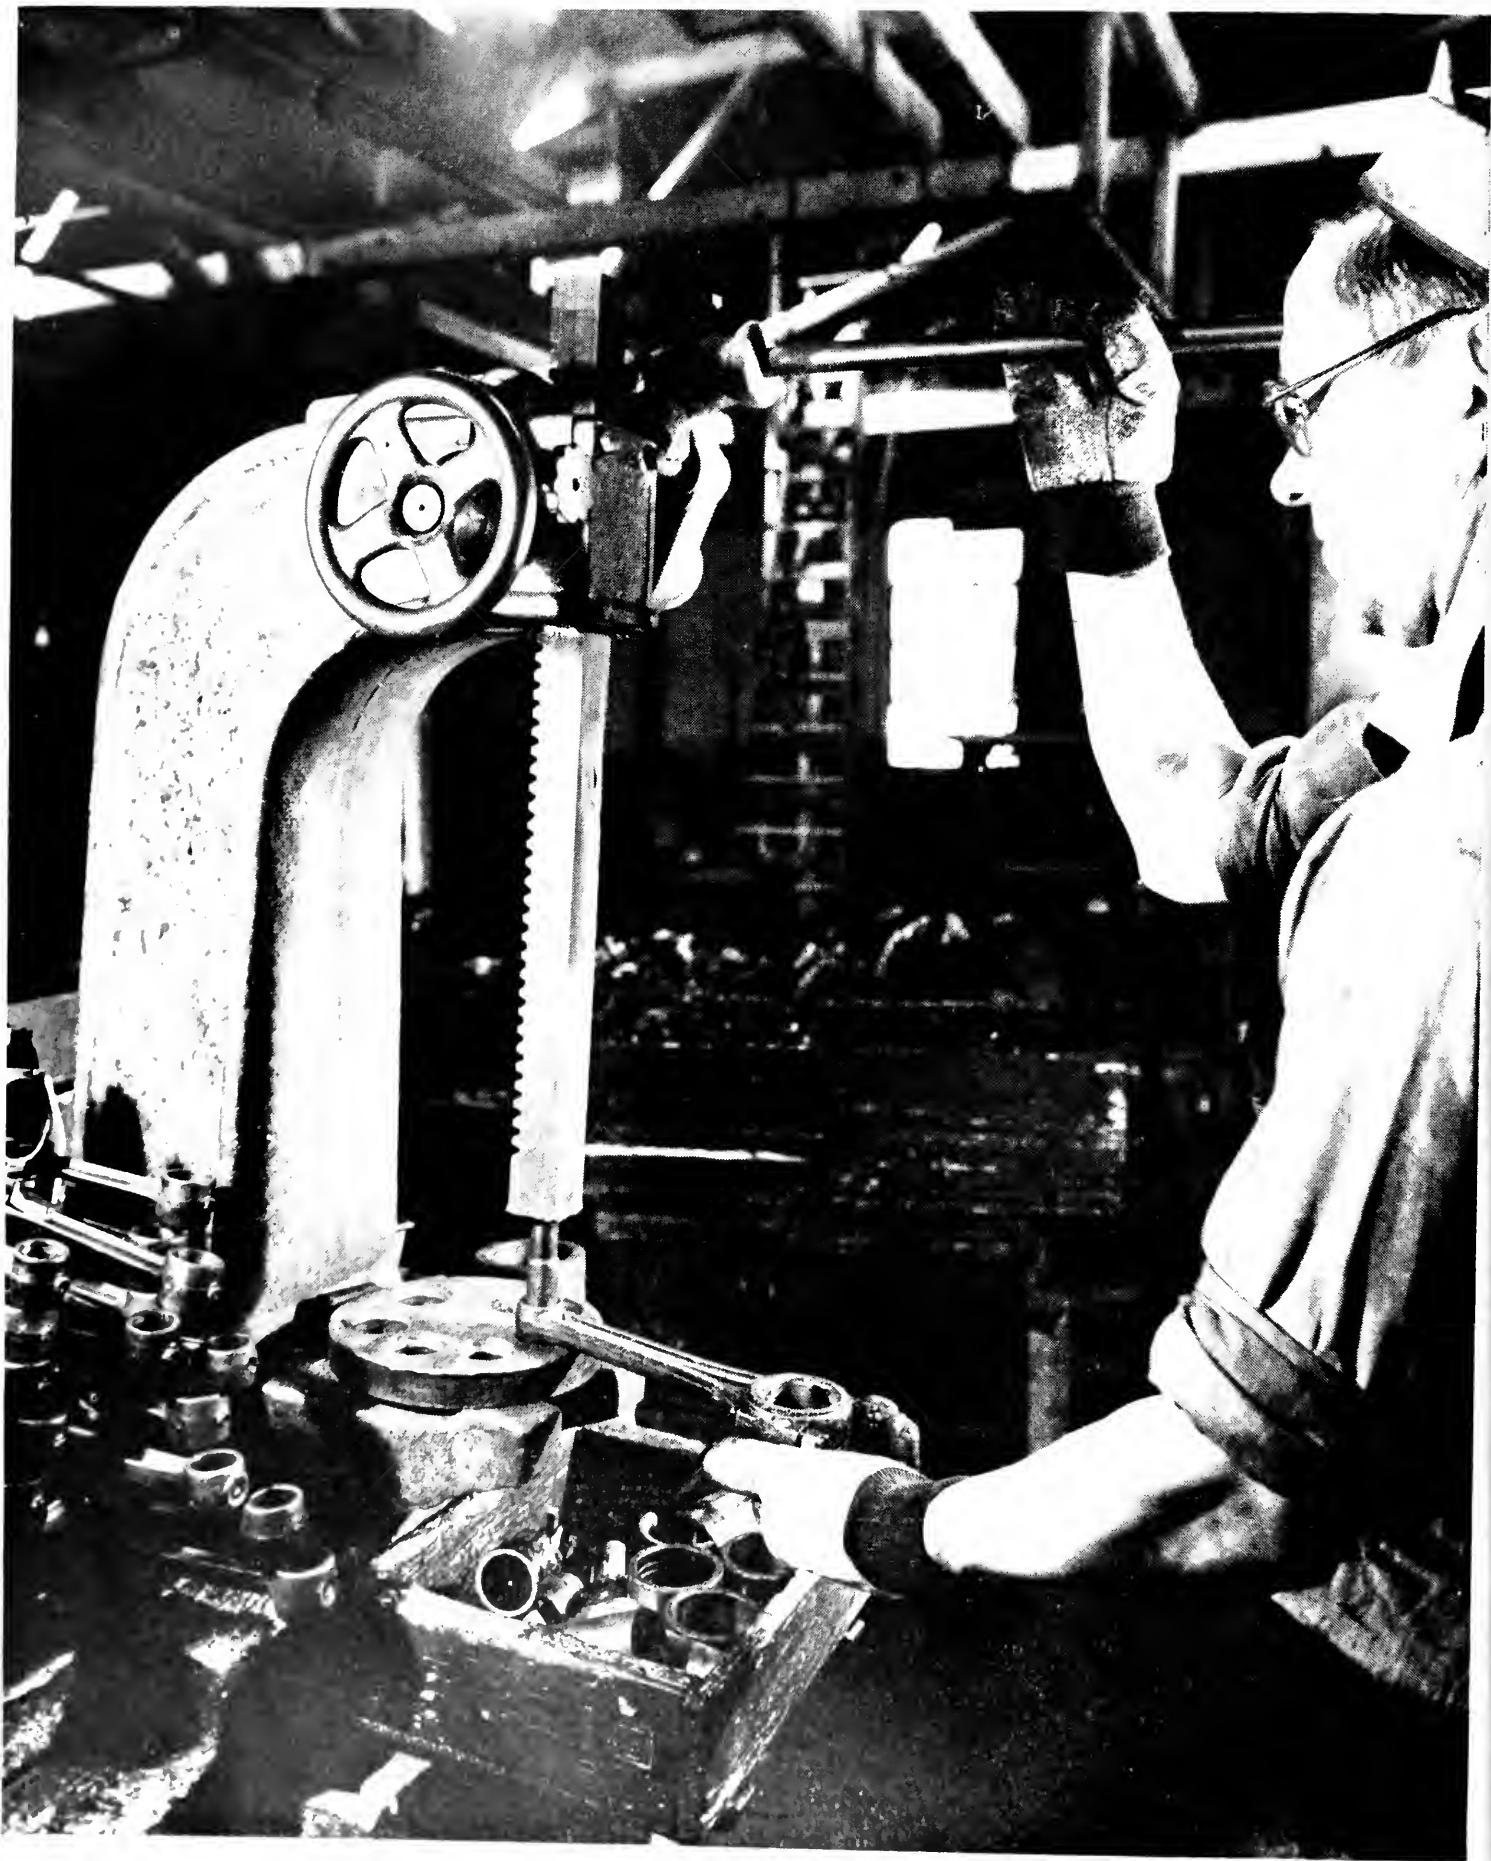
PLAINTIFF'S EXHIBIT No. 4

Other pin bushings have a heavy wall and are removed by use of an ordinary arbor press as shown above. It is much simpler and faster to remove the bushings in this manner.

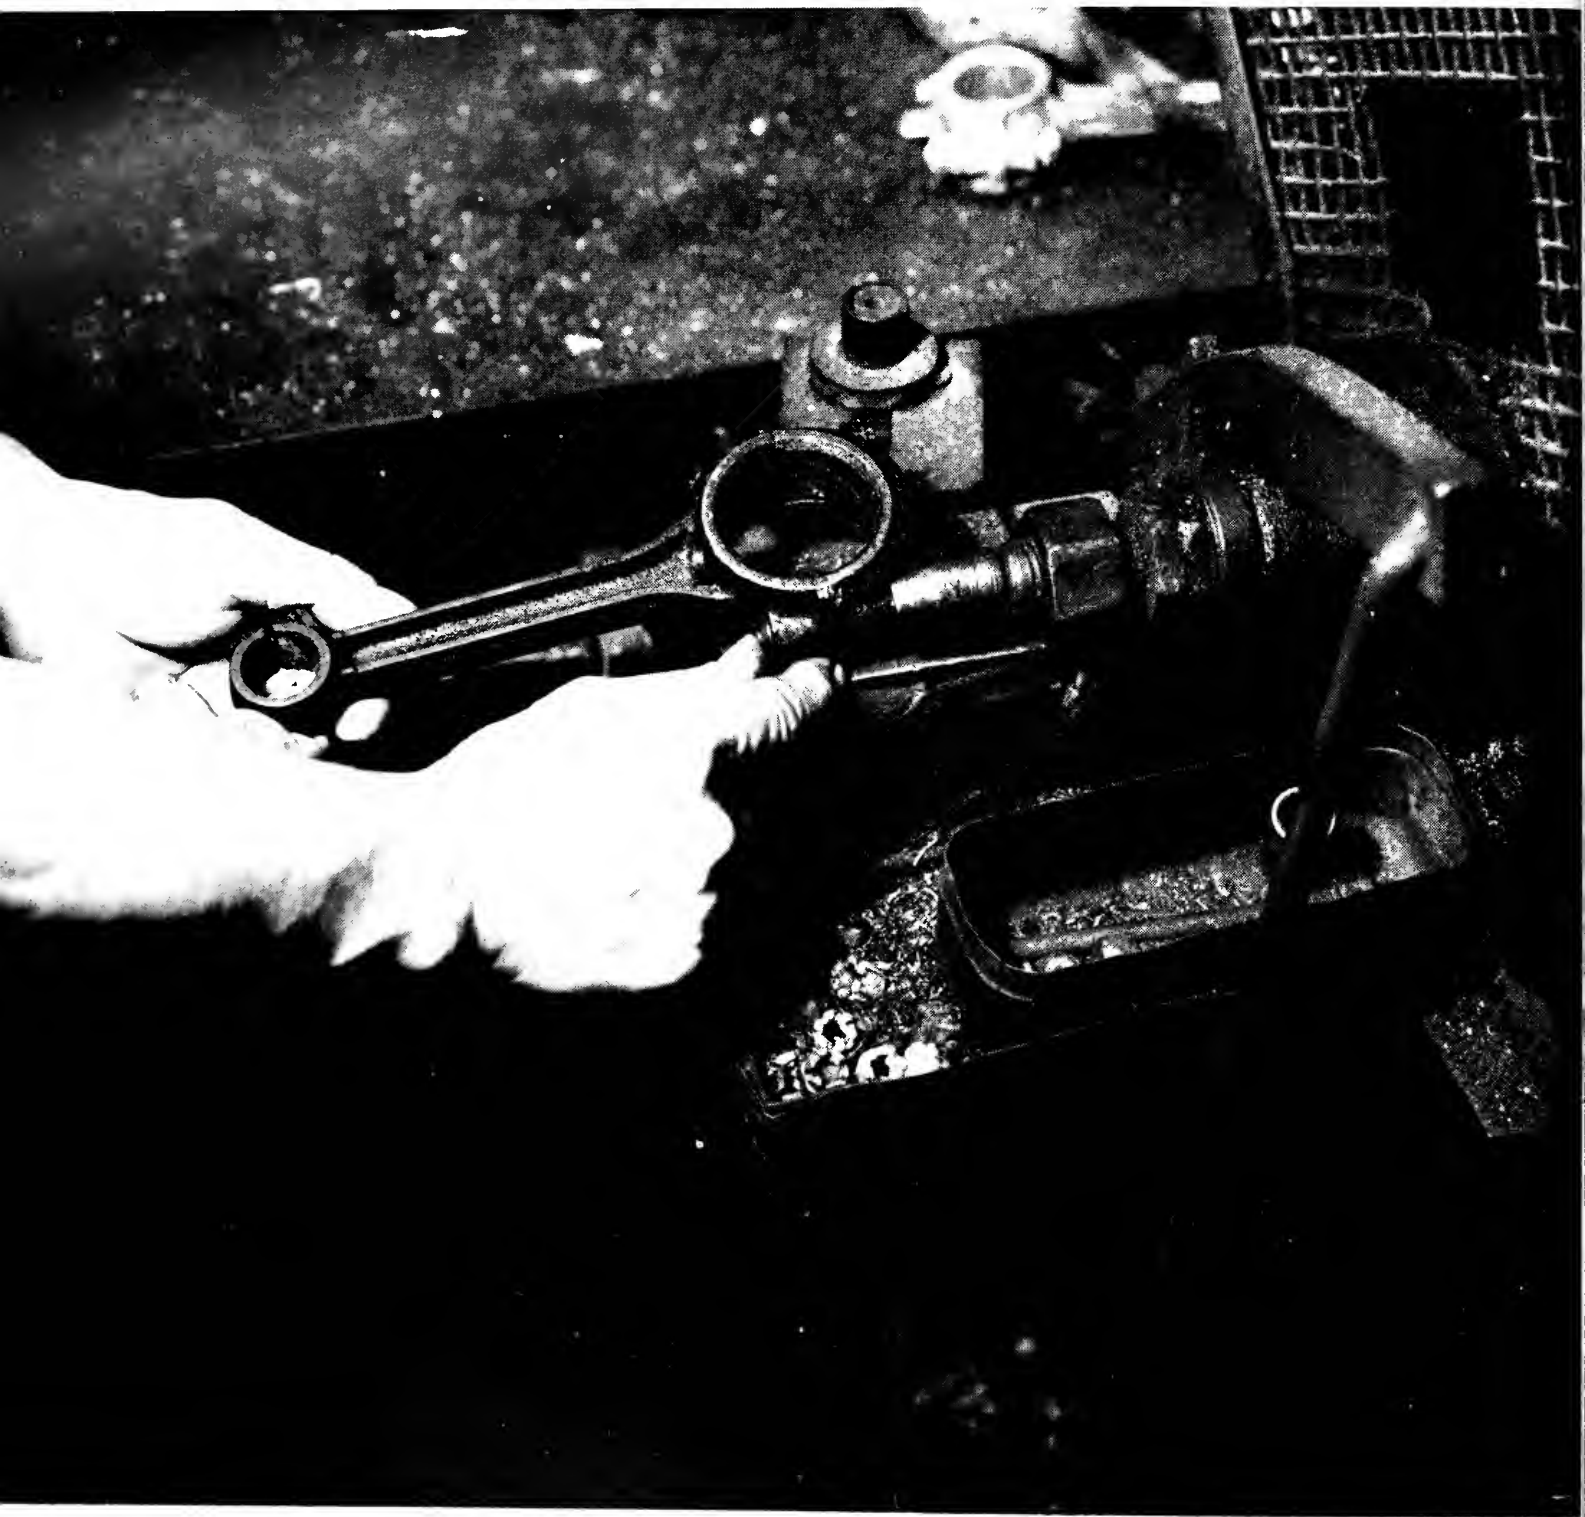
PLAINTIFF'S EXHIBIT No. 5

On about one half of the rods it is necessary to remove the bolts and nuts which fasten the cap to the shank and replace these bolts and nuts with auxiliary bolts and nuts which have already been dipped in solder. The nuts and bolts so removed are placed in a box and later replaced on the rods in place of the auxiliary nuts and bolts when the rebabbiting process is completed. The same cap always goes back on the same shank otherwise in the centrifugal casting the babbitt will leak. However, on Ford products the bolts are not removed for the reason that no bolts are made, but rather, a stud has been forged with the shank and cannot be removed. However, the nuts are similarly changed and for the same reason as in the case of the other rods. The reason for this operation is that on about one half of the types of rods the nuts and bolts have never been immersed in solder, and it is desired to rebabbit the rod so that its appearance resembles that of its original condition as nearly as possible. On the other one half of the rods, that is on the rods on which the nuts and bolts have previously to the time received by Plaintiff corporation been immersed in solder, there is no necessity for this operation, and the nuts and bolts are merely tightened if they are loose. The tightening of the nuts and bolts is accomplished by means of an ordinary hand socket wrench attached to a slowly revolving power driven spindle operated by means of a foot lever as shown above. The opposite end of this spindle revolves in the opposite direction and is used in loosening and removing the nuts and bolts, by the same type socket.

Then the steel separator shims are removed by the means of the socket wrench shown in picture number five, and any auxiliary nuts and bolts are removed and the originals replaced.

The cap is replaced on the rod using the original bolts and nuts, the removal of which was described in Picture 5. A power driven socket wrench is used in performing this operation.

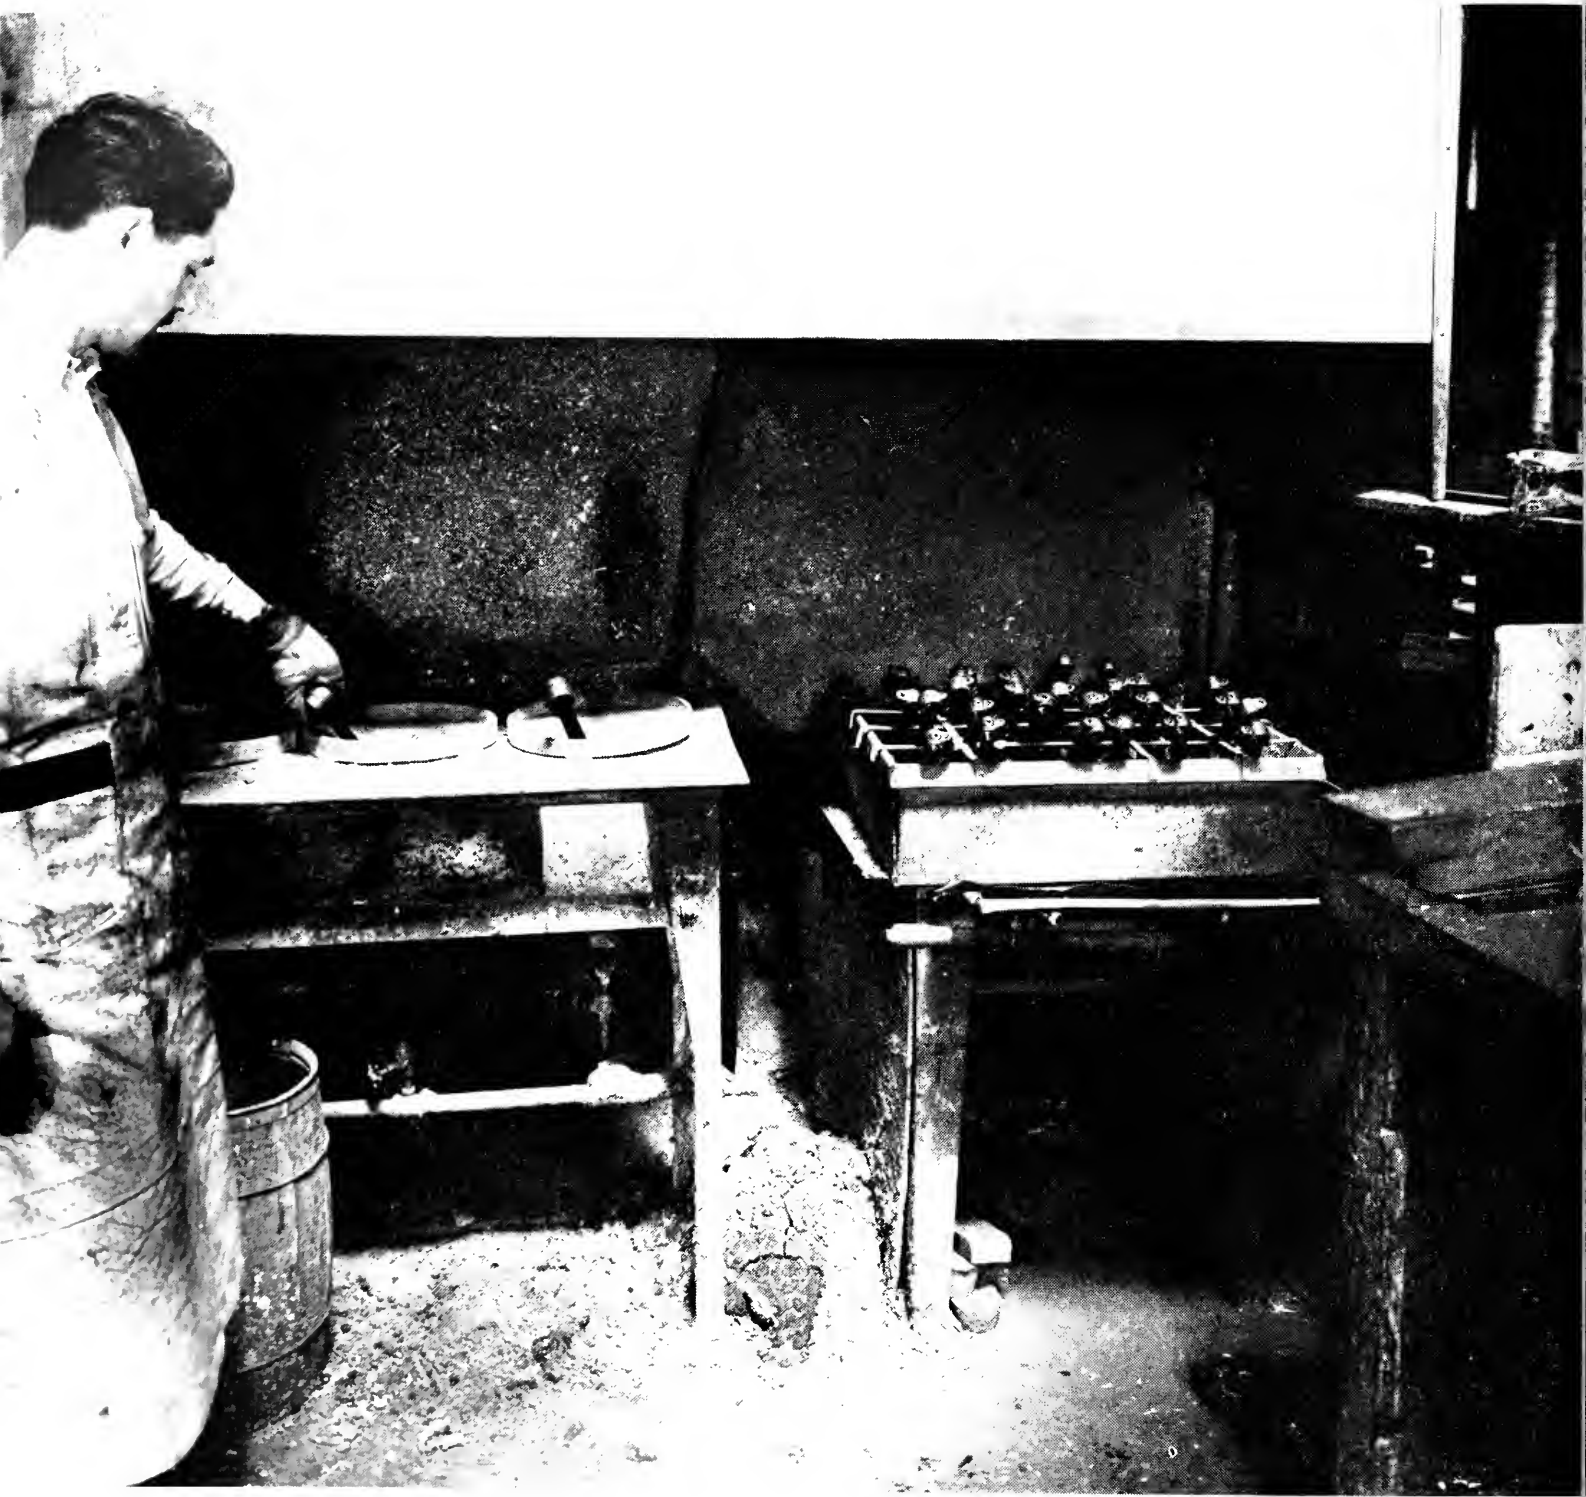
PLAINTIFF'S EXHIBIT No. 6

Then the babbitt is melted from the bearing end of the rod by placing that end into a low temperature pot of molten babbitt which the night man prepares by lighting the oven at approximately five o'clock in the morning in preparation for the days run. It is heated with an ordinary gas stove burner. This operation is illustrated in the right half of the above picture. After most of the babbitt is removed by this method, the remainder of the adhering babbitt or dross which sometimes clings to the rods is removed by dipping them into the dross pots shown to the left in the above picture. The dross pots keep a solution of molten babbitt at a higher temperature. In order to keep the babbitt at a sufficiently high temperature three approximately one half gallon pots are used. The reason for the babbitt being removed by two operations is that the babbitt in the low temperature receptacle may be used by Plaintiff corporation for rebabbitting, while the higher temperatures in the dross pots spoil the babbitt for such use.

Close-up of operation illustrated in picture 6.

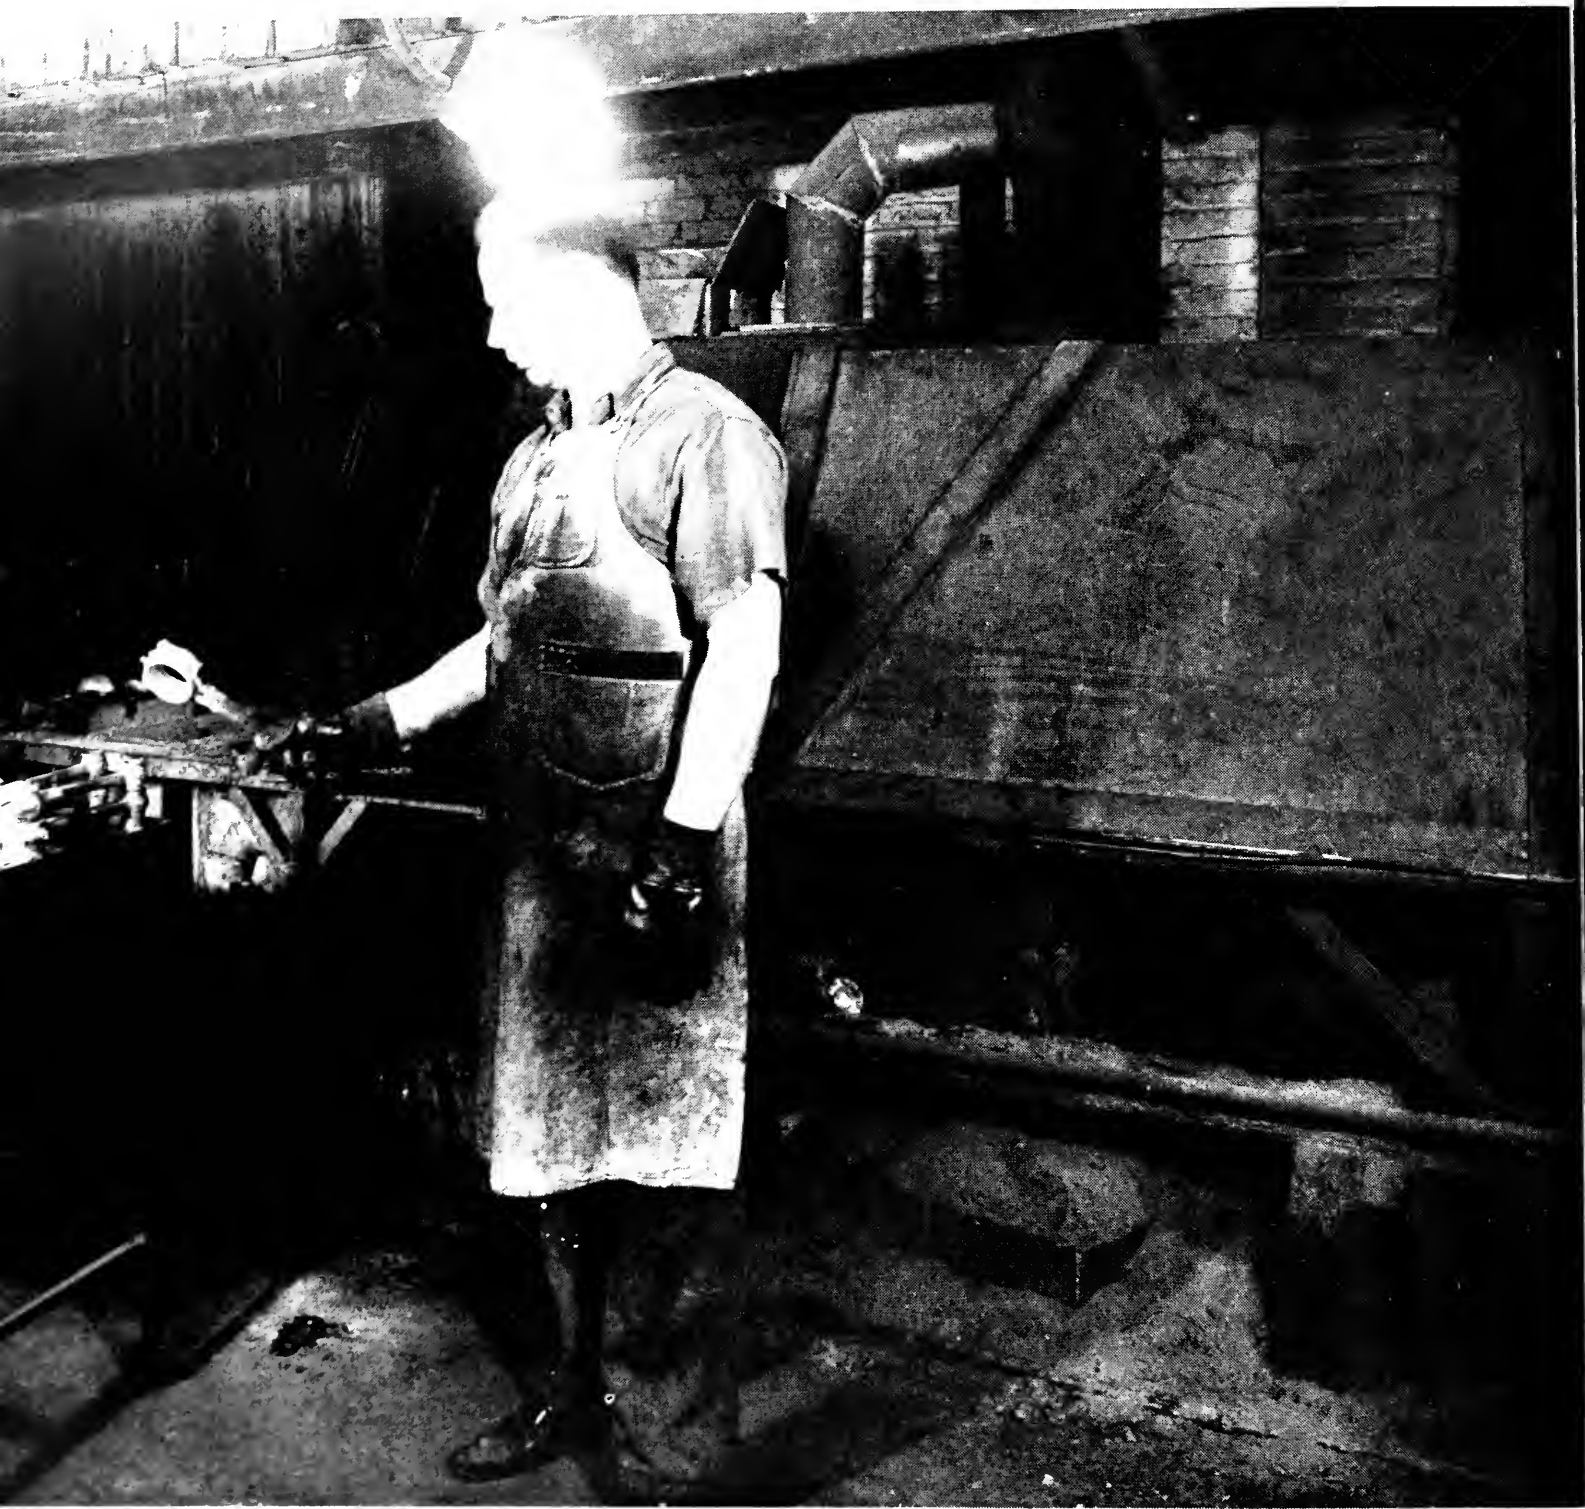
PLAINTIFF'S EXHIBIT No. 8

After any remaining babbitt is chipped off with a chisel, the bearing end of the rod is then dipped into a solution of hydrochloric acid. The acid acts as a cleaning agent. The acid vat is under the wooden cover shown at the right in the above picture. Then the bearing end of the rod is dipped into a molten tin or solder shown on the left in the above picture. This solder or tin acts as a flux or bond when the babbitt is cast against it.

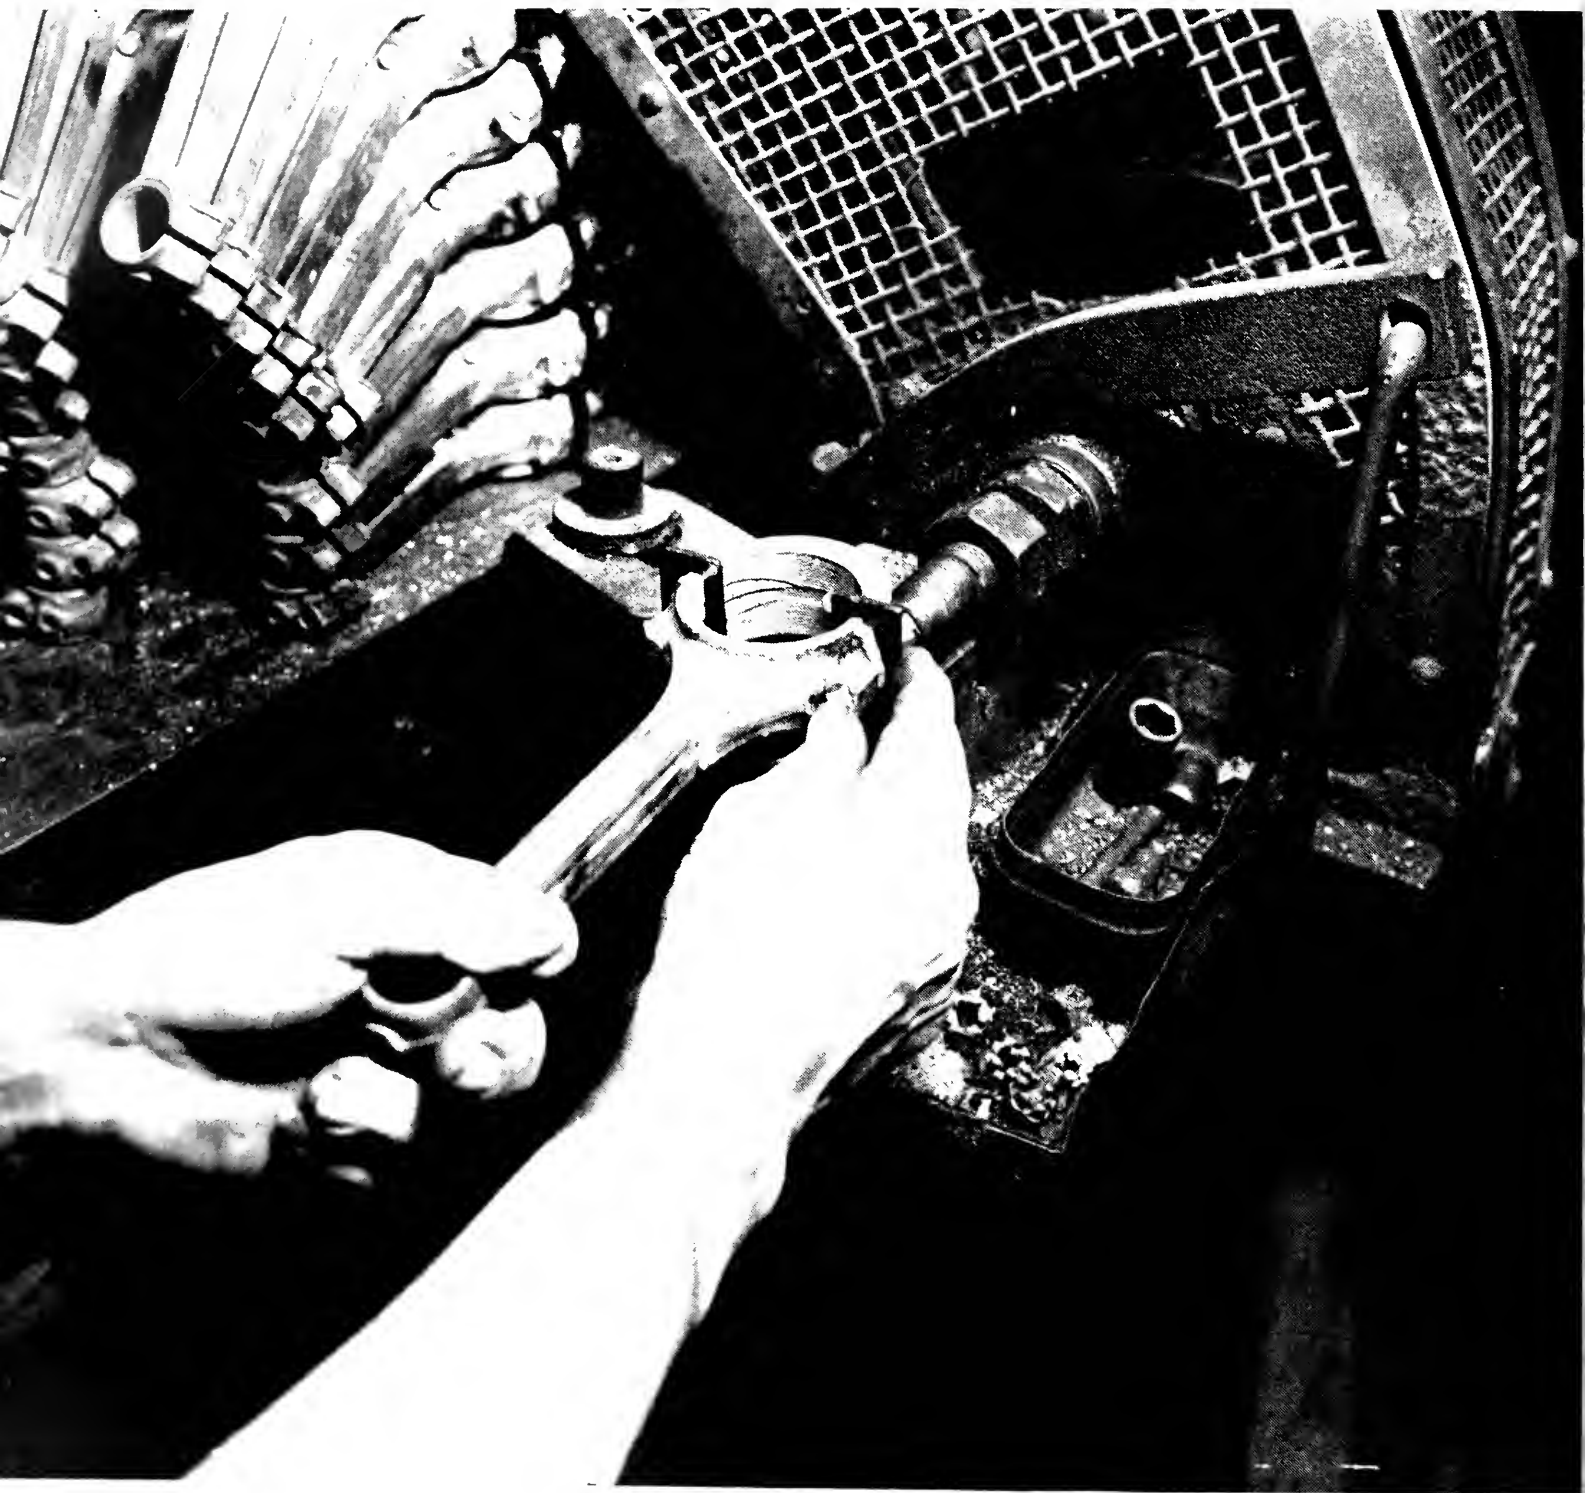
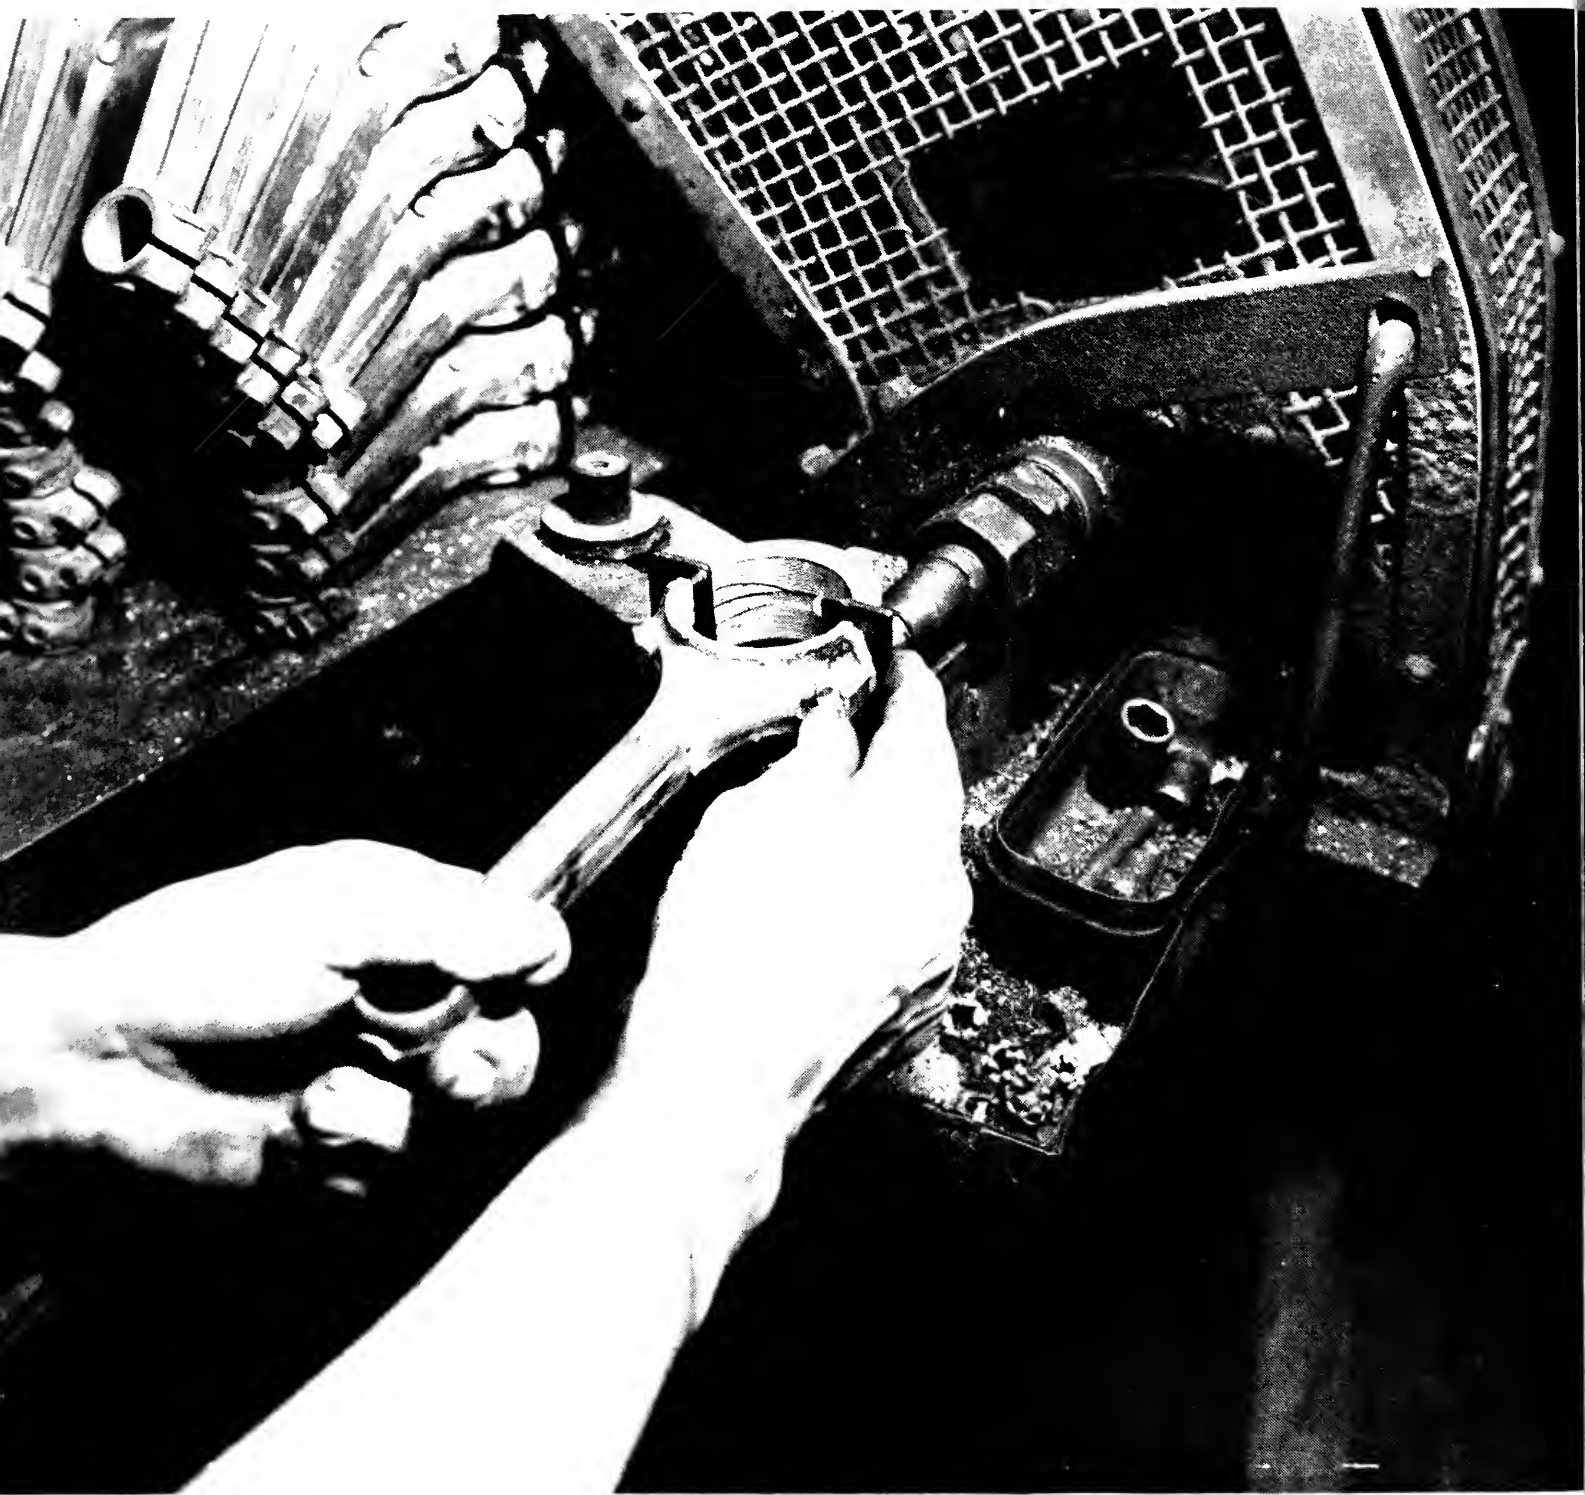
PLAINTIFF'S EXHIBIT No. 9

Then the nuts are removed from the bolts holding the cap to the bearing end of the rod and by means of a sharp blow the cap is removed from the bearing end of the rod, and a steel separator is inserted between the cap and the bearing end of the rod on each side where the cap joins the rod as shown above. These separators prevent the rod and cap from casting together when the babbitt is rebabbitted. The same power driven socket wrench described in picture number 5 is used for the removing of the nuts and for the replacing of the nuts when the separators have been inserted. Separators are not used in rebabbiting rods for Model A Ford engines for the reason the cap is cast to the bearing end of the rod.

Then the nuts are removed from the bolts holding the cap to the bearing end of the rod and by means of a sharp blow the cap is removed from the bearing end of the rod, and a steel separator is inserted between the cap and the bearing end of the rod on each side where the cap joins the rod as shown above. These separators prevent the rod and cap from casting together when the babbitt is rebabbitted. The same power driven socket wrench described in picture number 5 is used for the removing of the nuts and for the replacing of the nuts when the separators have been inserted. Separators are not used in rebabbiting rods for Model A Ford engines for the reason the cap is cast to the bearing end of the rod.
